Florida contractors put a UHD machine to work on a demo project at the Kennedy Space Center.

ALL SYSTEMS

GO

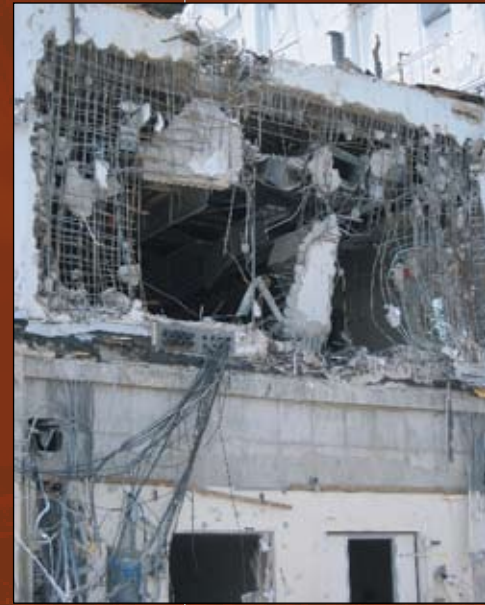
The high concentration of rebar in SAEF II was a challenge for the demolition team.

We discovered reinforcing bars at 8 inches on center, with

two pieces of No. 11 rebar [1.27-inch diameter] running in both directions. The walls were 12 inches thick, and the slab was 10 inches. When we finally broke this animal down, it was time to play with the footers. At 14 feet below grade, we found the footing bottoms and removed the last of the concrete. This monster took every bit of four weeks to drop and pull out of the ground.
